PRIMARY RECORD

* Resource Name or #: 2529 San Marcos Avenue, APN 453-713-07

BUILDING, STRUCTURE, AND OBJECT RECORD

The building is within the Burlingame Historic District.

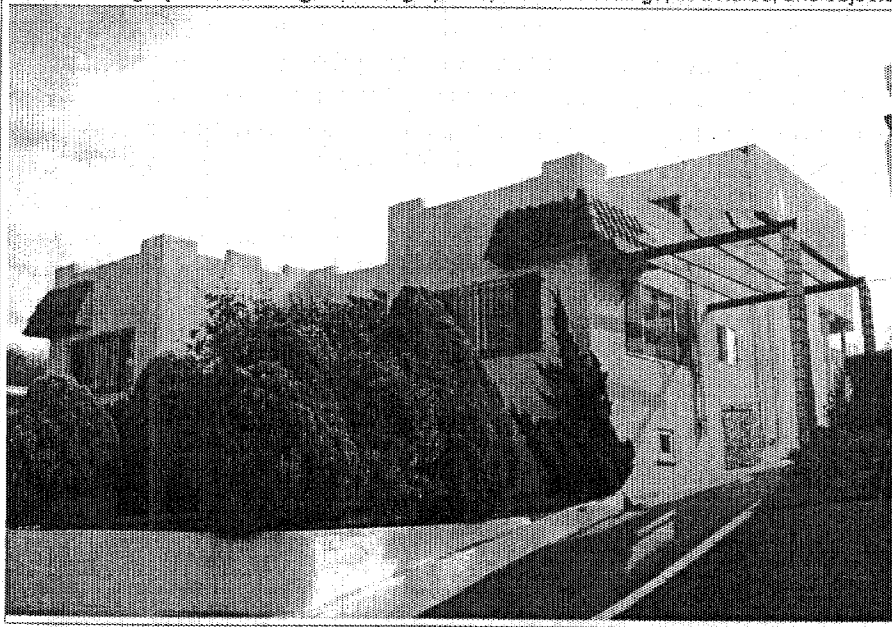
Photo Number: P0002988.JPG Est. Date: 2001

* P3a. Description: (Describe resource and its major elements. Include design, materials, condition, alterations, size, setting, and boundaries.)
This house was built in 1926 in the Mission Revival style. The house is one and two stories with a flat roof, parapet wall, and rectangular projections throughout. The exterior wall material is stucco. The second floor in back is an addition; the original house appears to be one story. Two projecting bays of equal size are linked by a middle entry patio with trellis. The bays have a slightly projecting Spanish style roof corner detail which has been redone with "S" tile. The side vents are paramental projections. The aluminum windows throughout the house appear recent. The house has security railings on the windows and doors throughout that detract from its appearance, but are reversible. The rear garage is of a similar design to the house. The house is raised ten feet above the sidewalk. The house is located in the community of Burlingame. It is in good condition. The total usable floor area is 1,684 square feet. The total lot area is 4,900 square feet. Update: As of 3/8/2002, the Spanish style corner roof details and wrought iron security bars have been removed and the windows were replaced with wood casement windows with multi-lights on top.
